NUMBER 001

28/02/2005

GM 16V / Synchronous Drive / Installation Info.

GATES REFERENCE:	5368XS, 5369XS, 5408XS, 5461XS, 5499XS, 5542XS & their relevant kits.

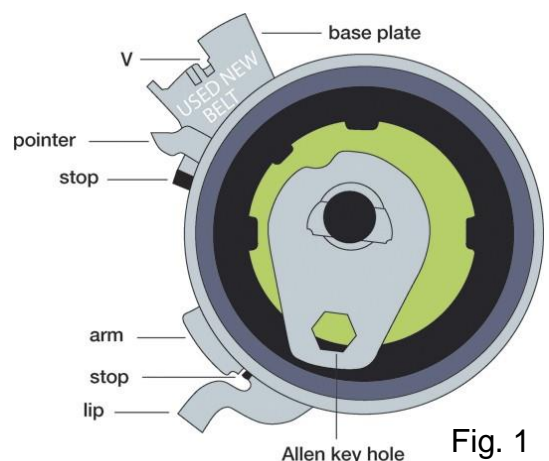
Fig. 1

- Align Top Dead Centre (TDC) marks. As the same engine used in different models can have a different belt, we give here the TDC marks following the belt number, not following the engine code.
5369XS, 5499XS crankshaft: 5 o'clock, L-cam: 3 o'clock, R-cam: 9 o'clock
5368XS, 5408XS, 5461XS, 5542XS: crankshaft: 6 o'clock, camshafts 12 o'clock.
- Lock the camshafts.
- Loosen the tensioner bolt.
- Turn the tensioner clockwise and remove the belt.
- Remove the old tensioner.
- Install the new tensioner, hand tighten the bolt. The tensioner lip **has to be** in the oil pump housing slot. (The tensioner pointer has to sit behind water pump pulley). The Allen key hole **has to be set** in +/- 7 o'clock position as shown in Fig. 1.

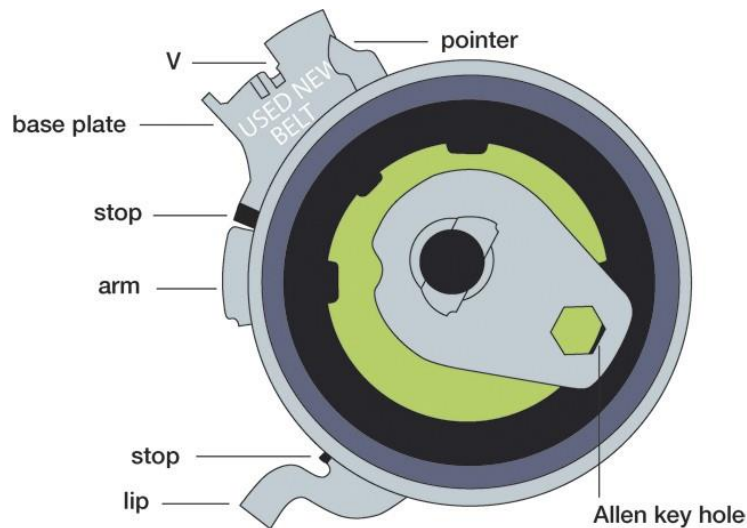
Fig. 2

8. Turn the tensioner (with the Allen key) anti-clockwise (while holding the bolt in place) till the pointer is in line (not passing) with the right hand side of the base plate (fig. 2).

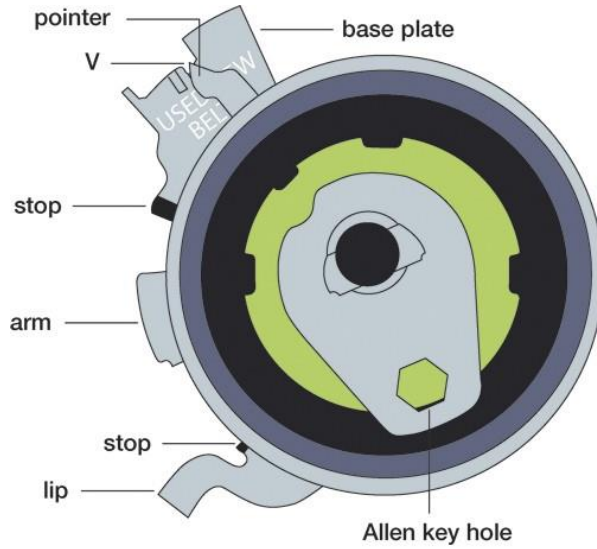
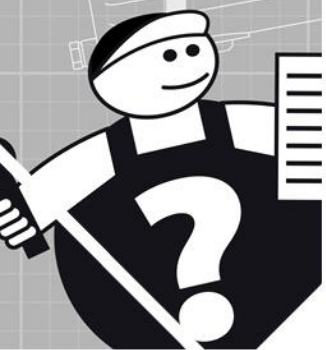
Fig. 3

12. If the pointer is not in line with V ("NEW" position), lock the camshafts again.
13. Loosen the tensioner bolt.
14. Adjust the tensioner (while holding the tensioner bolt in place), till the pointer is in line with V ("NEW" position); the Allen key hole has to be in +/- 5 o'clock position now (Fig. 3).

15. Tighten the tensioner bolt (+/- 20 Nm).
16. Unlock the camshafts.
17. Turn the engine 2 revolutions (via the crankshaft), till TDC marks align again.

18. Check the tensioner pointer position. If correct (pointer in V), install the other removed parts. If not correct, do repeat steps from 13 to 18, until the pointer aligns with V ("NEW" position).

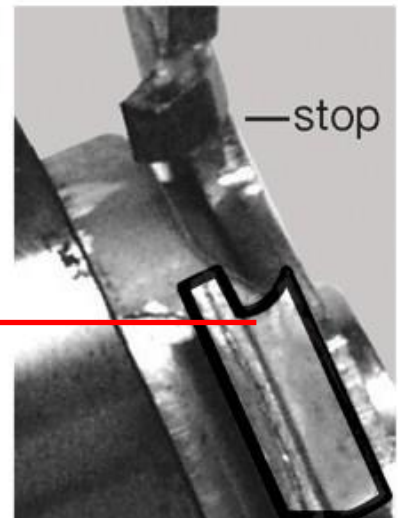
Rotating the tensioner in the wrong direction, having the Allen key hole in a wrong position to start off, not turning the engine 2 revolutions before and after setting the tension, can lead to system failure. This will cause the arm of the tensioner to hit the stop, creating a hammering noise, damaging and possibly even rupturing that part. This failure mode is very common and can easily be recognised when inspecting the edge of the arm (Fig. 4). The resulting wrong tension can cause the belt to rupture.

“damaged”
